Bearing failures and their causes

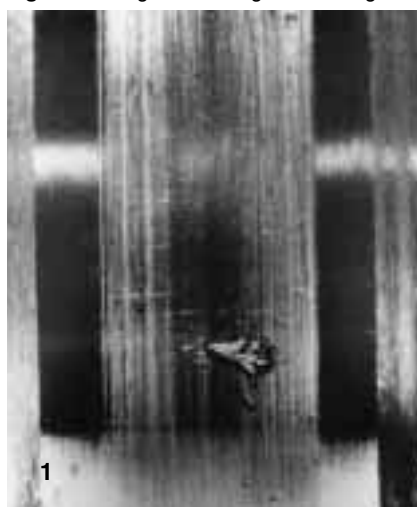
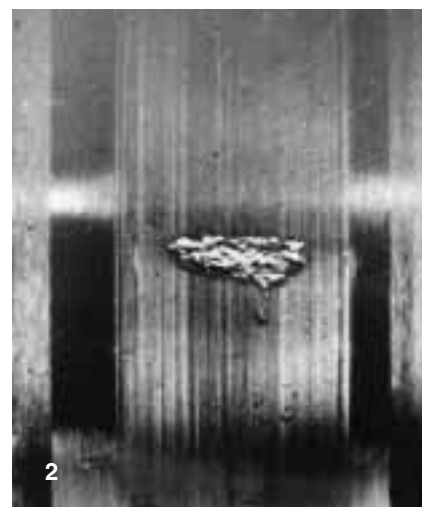
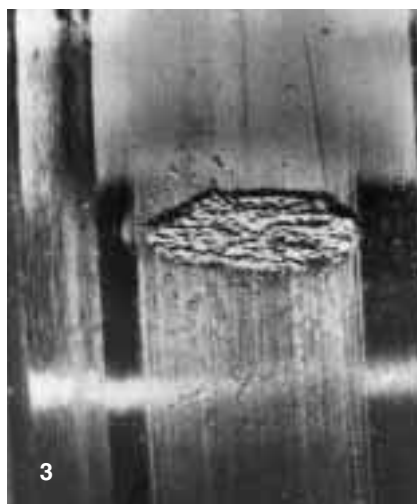
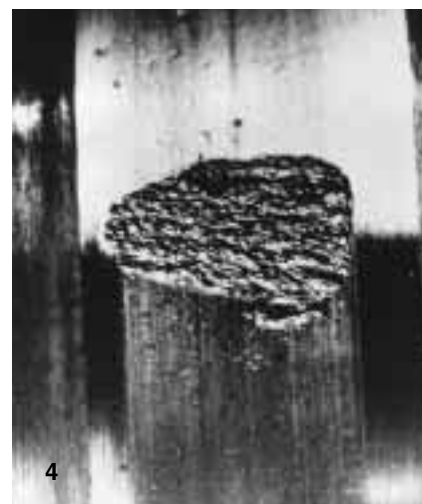
Figs 1–4 Progressive stages of flaking

magnitude of the load. Fatigue is the result of shear stresses cyclically appearing immediately below the load carrying surface. After a time these stresses cause cracks which gradually extend up to the surface. As the rolling elements pass over the cracks fragments of material break away and this is known as flaking or spalling. The flaking progressively increases in extent (figs 1 to 4) and eventually makes the bearing unserviceable.

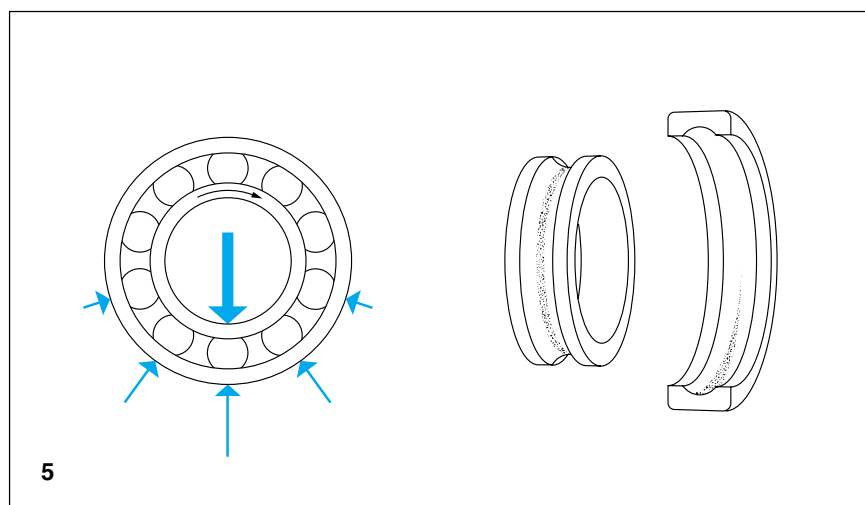
Fig 5 Uni-directional radial load. Rotating inner ring – fixed outer ring.
Inner ring: path pattern uniform in width, positioned in the centre and extended around the entire circumference of the raceway
Outer ring: path pattern widest in the load direction and tapered off towards the ends. With normal fits and normal internal clearance, the pattern extends around slightly less than half the circumference of the raceway

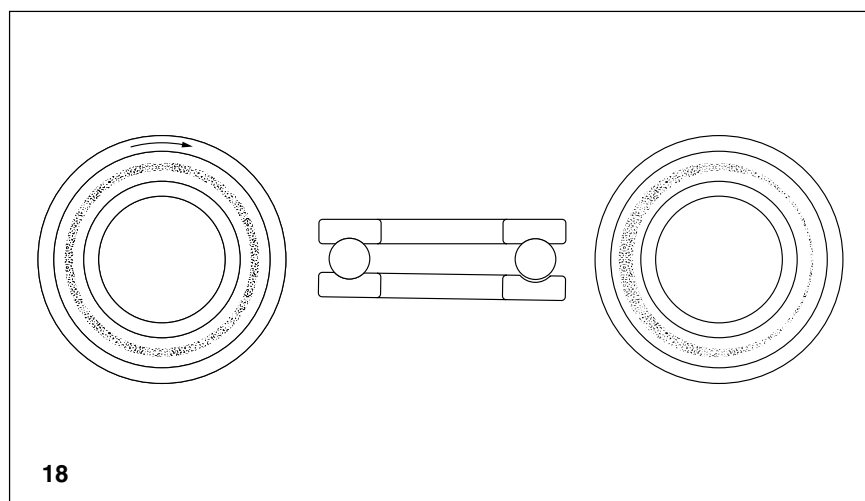
Fig 18 Housing washer misaligned. Rotating shaft washer – fixed housing washer.
Shaft washer: path pattern uniform in width, extended round the entire circumference of the raceway
Housing washer: path pattern in the centre of the raceway but wider around part of its circumference

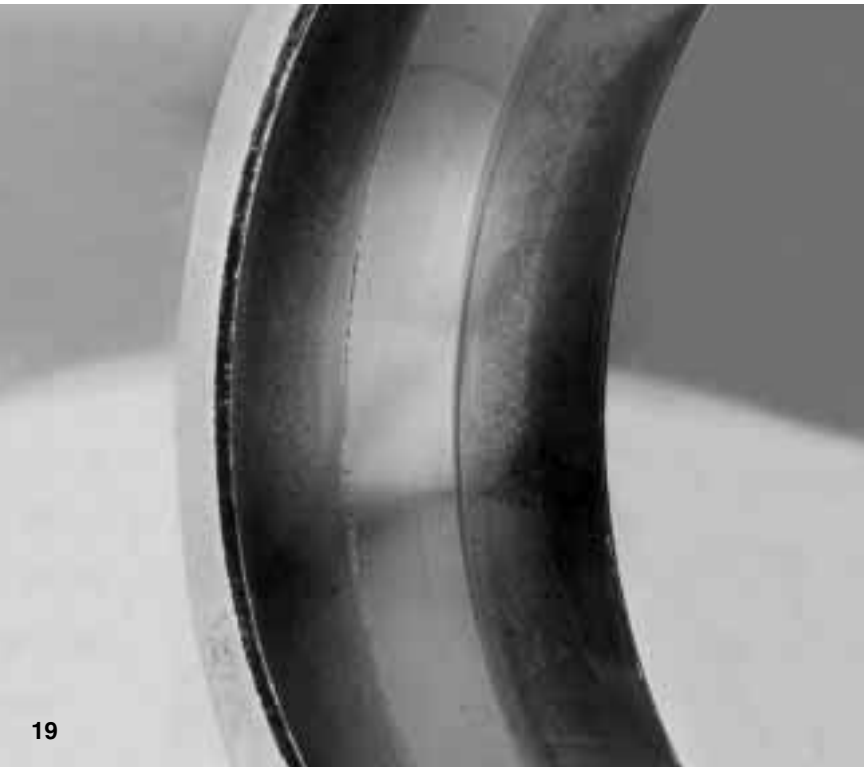
Fig 19 Outer ring of a spherical roller bearing with raceways that have been worn by abrasive particles. It is easy to feel where the dividing line goes between worn and unworn sections

Small, abrasive particles, such as grit or swarf that have entered the bearing by some means or other, cause wear of raceways, rolling elements and cage. The surfaces become dull to a degree that varies according to the coarseness and nature of the abrasive particles. Sometimes worn particles from brass cages become verdigrised and then give light-coloured grease a greenish hue.

Appearance	Cause	Action
Small indentations around the raceways and rolling elements. Dull, worn surfaces.	Lack of cleanliness before and during mounting operation.	Do not unpack bearing until just before it is to be mounted. Keep workshop clean and use clean tools.
Grease discoloured green.	Ineffective seals.	Check and possibly improve the sealing.
	Lubricant contaminated by worn particles from brass cage.	Always use fresh, clean lubricant. Wipe the grease nipples. Filter the oil.

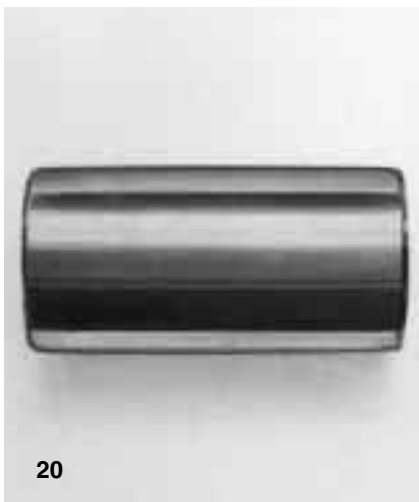
Fig 20 Cylindrical roller with mirror-like surface on account of lubricant starvation

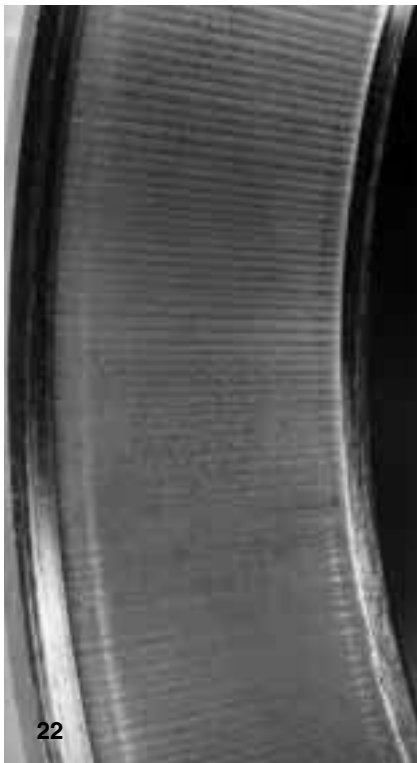
Fig 22 Outer ring of taper roller bearing damaged by vibration during operation

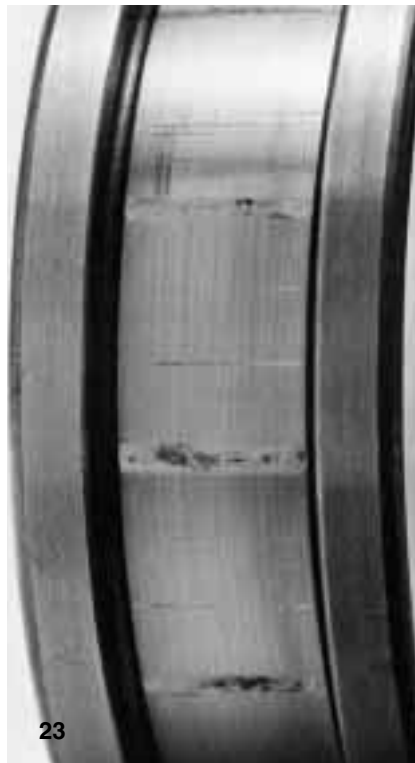
Fig 23 Vibration damage to the ring of cylinder roller bearing. The damage has arisen while the bearing was not running. It is evident, from the fainter fluting discernible between the pronounced depressions with corrosion at the bottom, that the ring has changed position for short periods

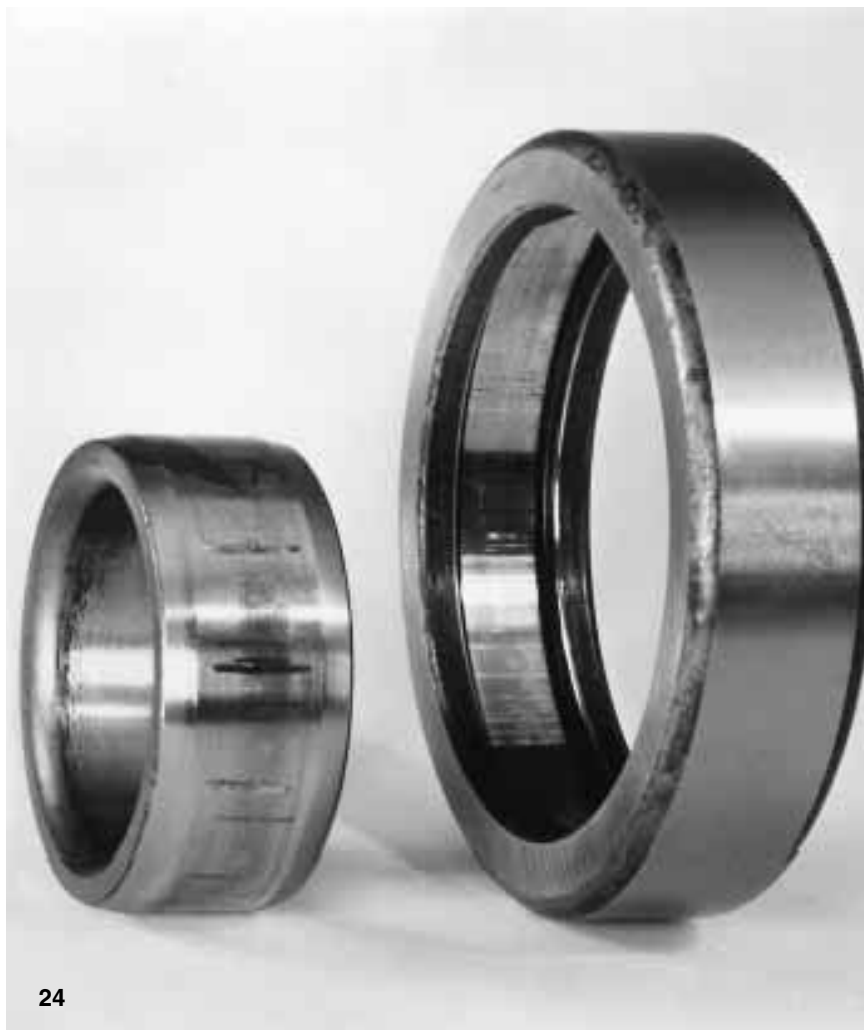
24

Fig 25 Spring loading a deep groove ball bearing to prevent vibration damage

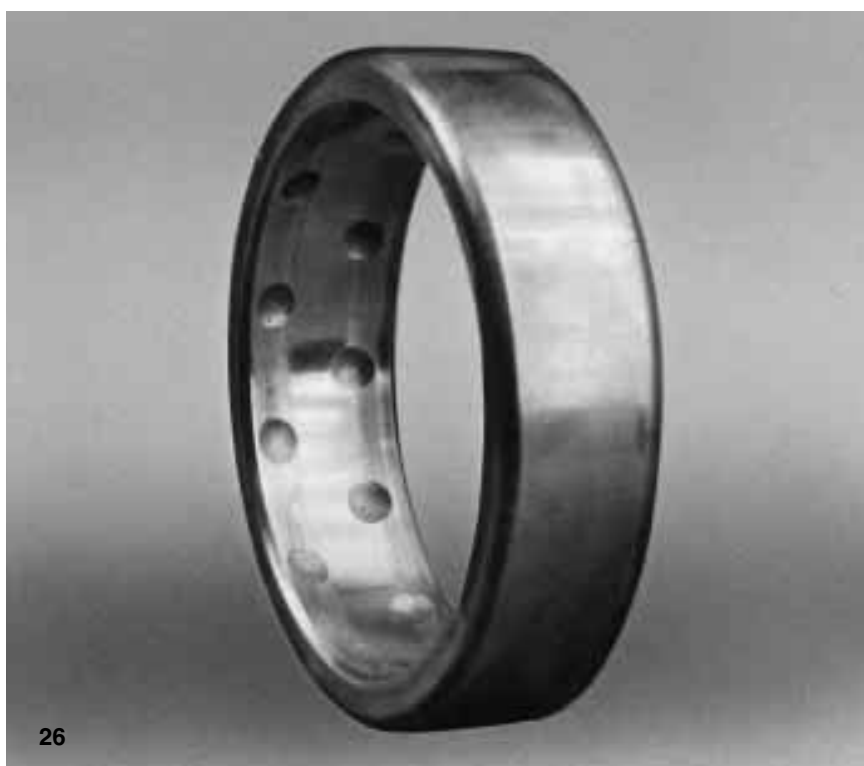
Fig 26 Outer ring of a self-aligning ball bearing damaged by vibration. The bearing has not rotated at all

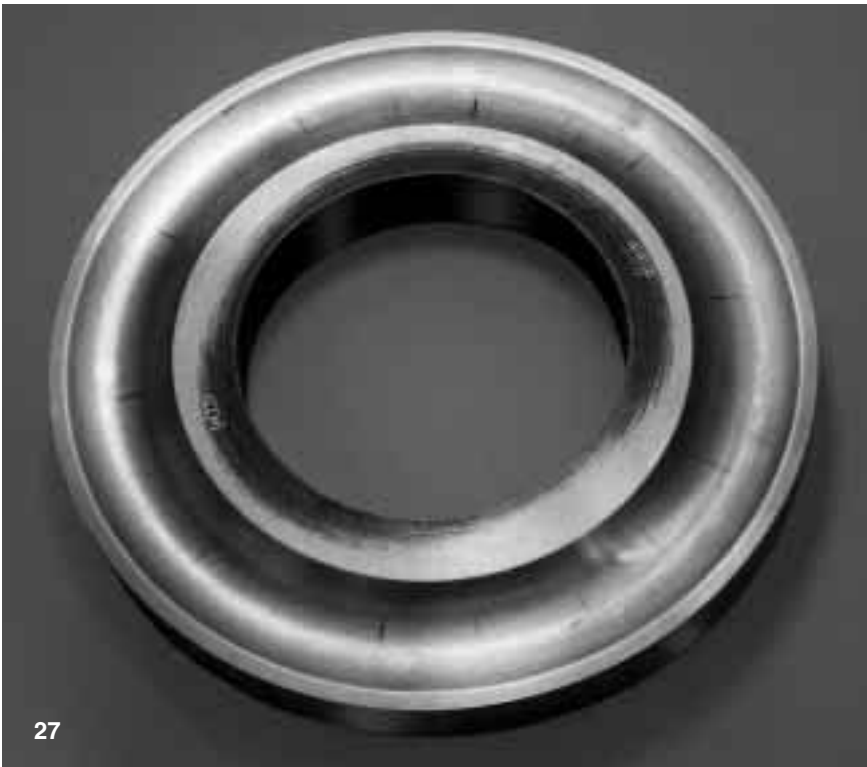
Fig 27 Washer of a thrust ball bearing subjected to overloading while not running. The indentations are narrow and radially aligned, not sphered as in radial ball bearings

Appearance	Cause	Action
Indentations in the raceways of both rings with spacing equal to the distance between the rolling elements.	Mounting pressure applied to the wrong ring.	Apply the mounting pressure to the ring with the interference fit.
	Excessively hard drive-up on tapered seating.	Follow carefully the SKF instructions concerning mounting bearings on tapered seating.
	Overloading while not running.	Avoid overloading or use bearings with higher basic static load ratings.

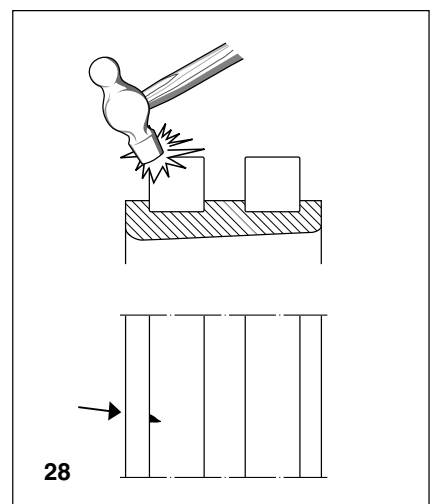
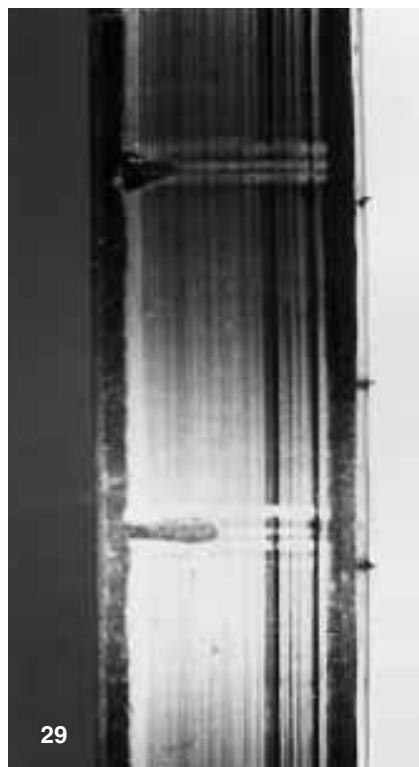
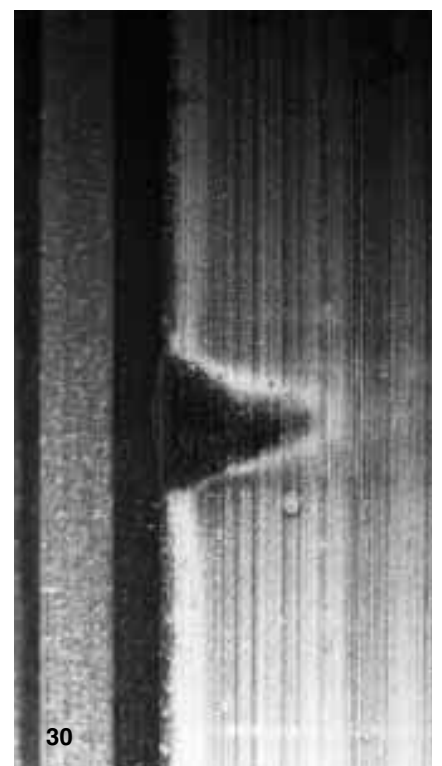
Figs 28–30 An example of the results of improper handling. A roller in a double row cylindrical roller bearing has suffered impact (fig 28). A periphery camera view of the roller shows two diametrically opposed indentations (fig 29). The roller has, in turn, dented the inner ring raceway (fig 30)

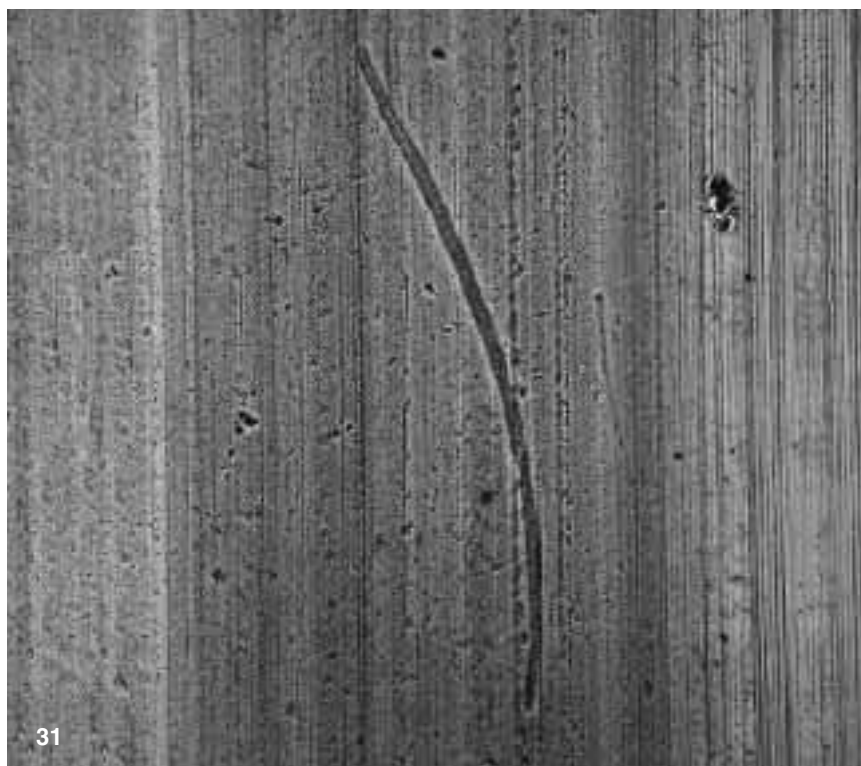
Fig 31 Indentations, caused by dirt, in one of the raceways of a roller bearing – 50 × magnification

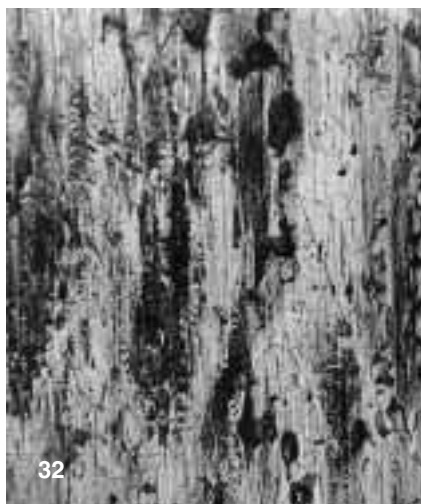
Fig 32 Smearing on the surface of a roller from a spherical roller bearing – 100 × magnification

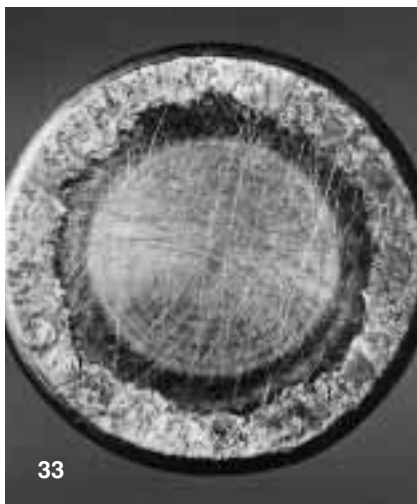
Fig 33 A cylindrical roller with end smearing caused by heavy axial loading and improper lubrication

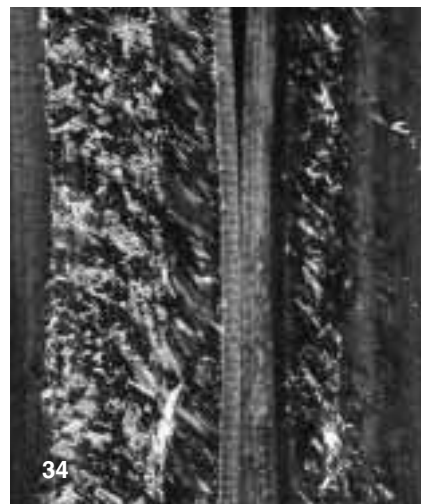
Fig 34 Guide flange smearing attributable to the same causes as the smearing shown in fig 33

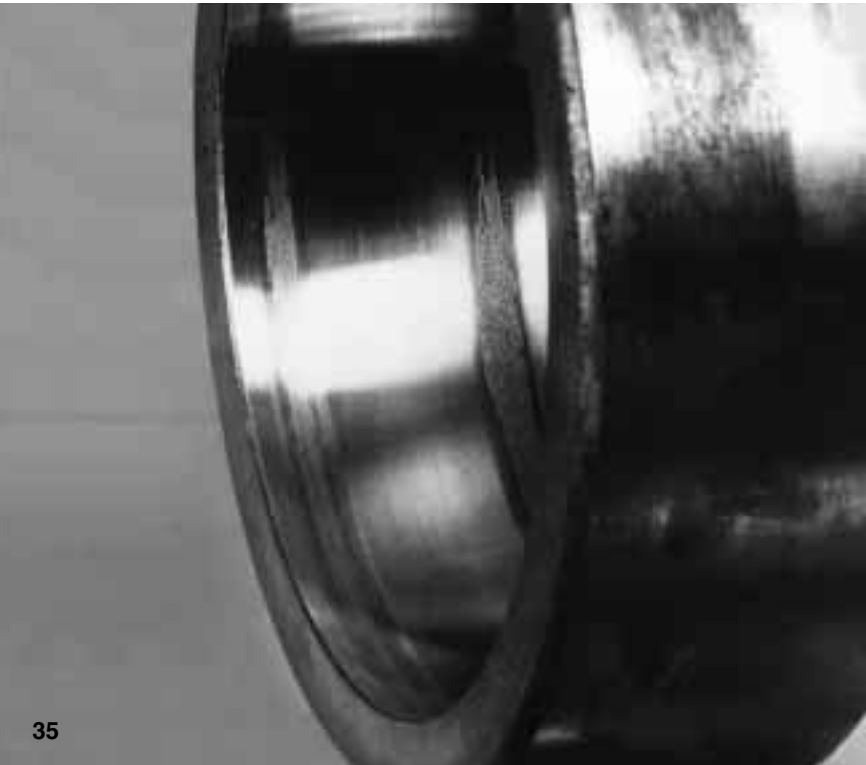
Fig 35 Skid smearing in both raceways of a spherical roller bearing outer ring

Appearance	Cause	Action
Scored and discoloured areas at the start of the load zone in raceways and on the surface of the rollers.	Roller acceleration on entry into the loaded zone.	More suitable lubricant. Reduce bearing internal clearance.

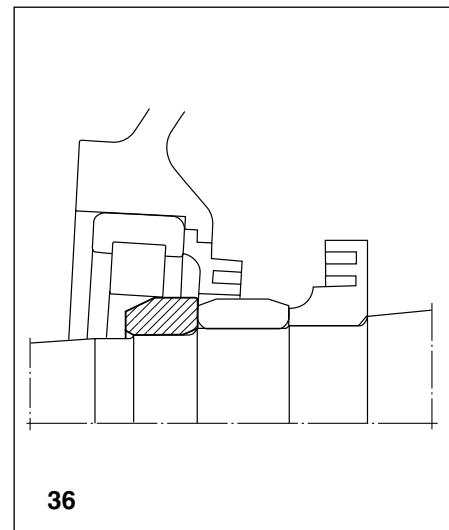
Fig 36 Mounting ring

Far too often, when cylindrical roller bearings are being mounted, the ring with the roller and cage assembly is entered askew, without being rotated. The rollers then scratch the raceway of the other ring, causing smearing in the form of long, transverse streaks. The rollers may be smeared too. This type of damage can be avoided if the bearing is well lubricated and one of the rings is rotated. When large numbers of bearings are to be mounted it is expedient to employ a mounting ring, see fig 36. Similar damage may arise if the bearing rings are mounted with fits

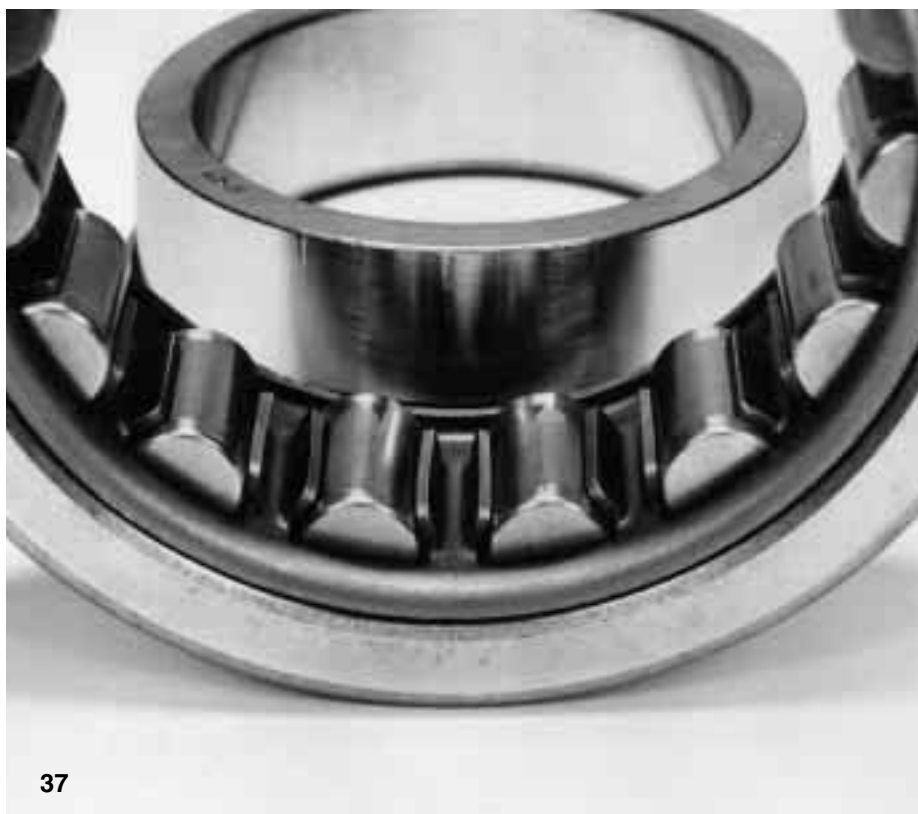
Fig 37 A cylindrical roller bearing with smear streaks in the inner ring raceway and on the rollers. The smearing has been caused by the roller assembly being entered askew without being rotated

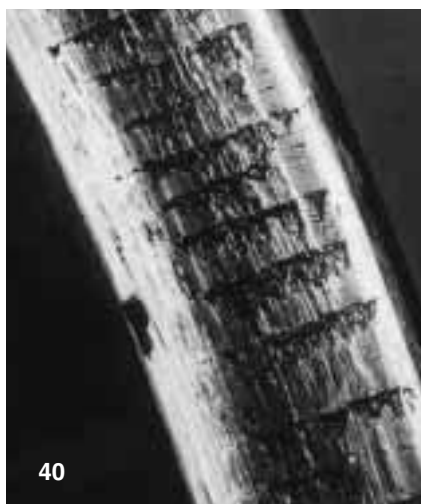
Fig 40 Smeared face of a cylindrical roller bearing inner ring

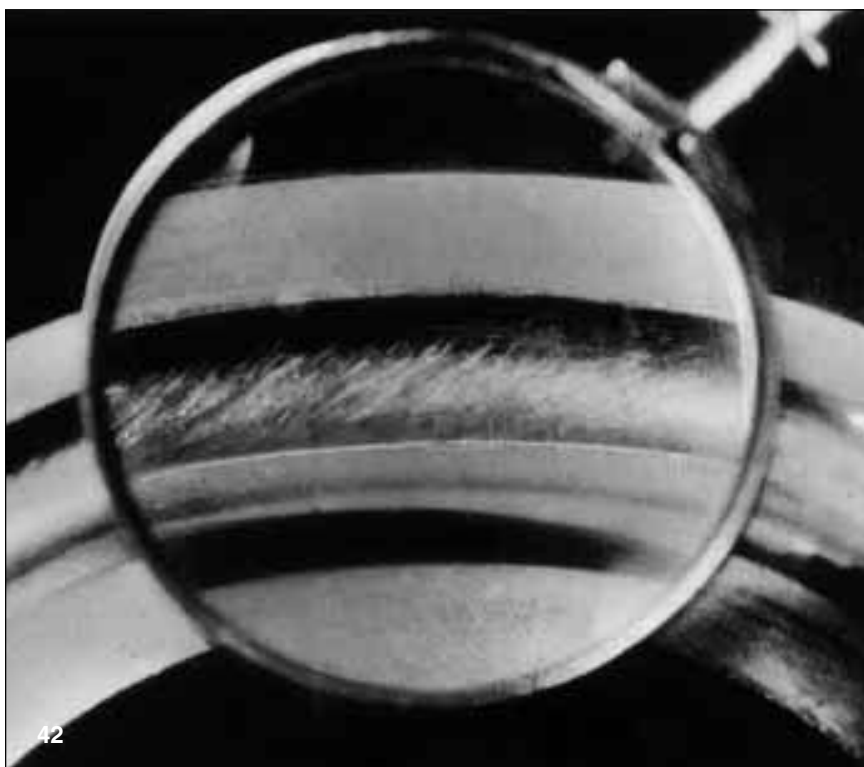
Fig 42 Thrust ball bearing raceway with smear streaks on account of the rotational speed having been too high in relation to the load

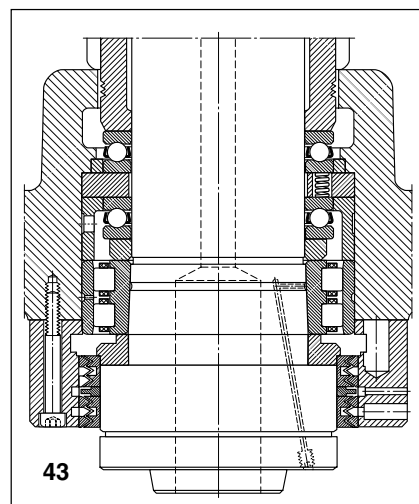
Fig 43 Preloading thrust ball bearings by means of springs

Preload the bearing by using springs.

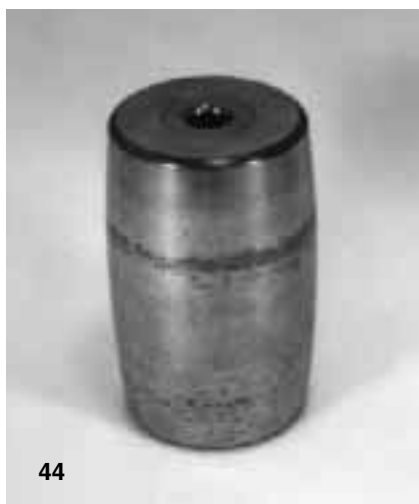
Fig 44 Surface distress in the form of a band encircling a roller from a spherical roller bearing

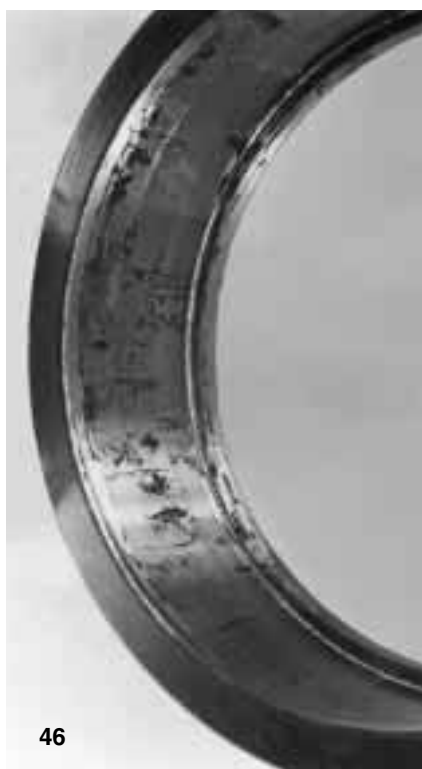
Fig 46 Deep seated rust in the outer ring of a cylindrical roller bearing

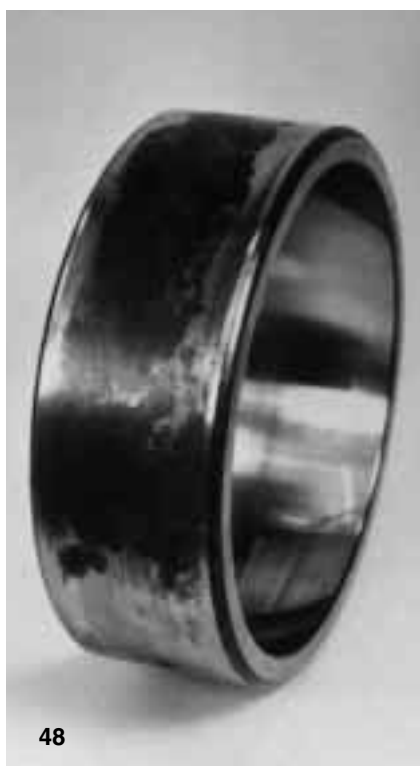
Fig 48 Fretting corrosion on the outer ring of a spherical roller bearing

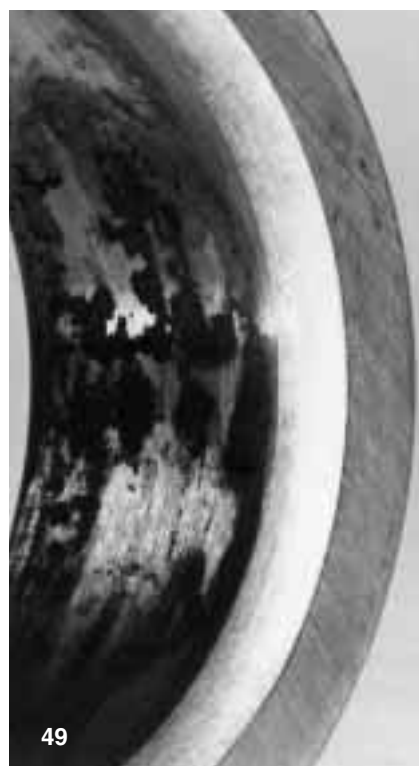
Fig 49 Extensive fretting corrosion in the bore of a self-aligning ball bearing

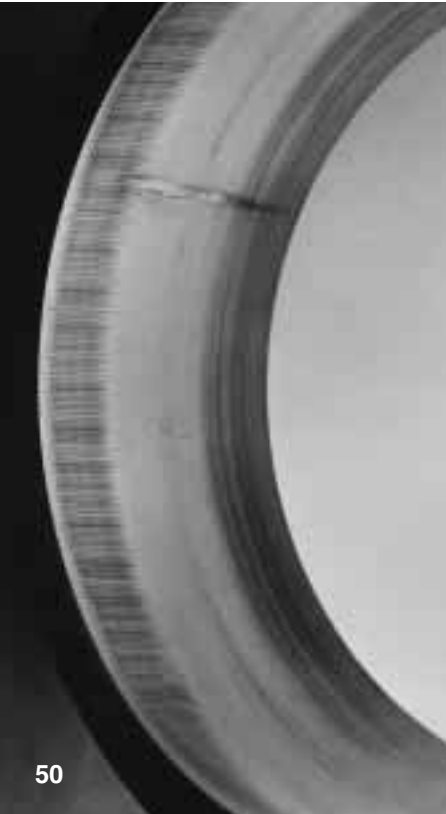
Fig 50 Fluting, caused by the passage of electric current, in the outer ring of a spherical roller bearing

Appearance	Cause	Action
Dark brown or greyish black fluting (corrugation) or craters in raceways and rollers. Balls have dark discolouration only. Sometimes zigzag burns in ball bearings raceways.	Passage of electric current through rotating bearing.	Re-route the current to by-pass the bearing. Use insulated bearings.
Localised burns in raceways and on rolling elements.	Passage of electric current through non-rotating bearing.	Re-route the current to by-pass the bearing. When welding, arrange earthing to prevent current passing through the bearing. Use insulated bearings.

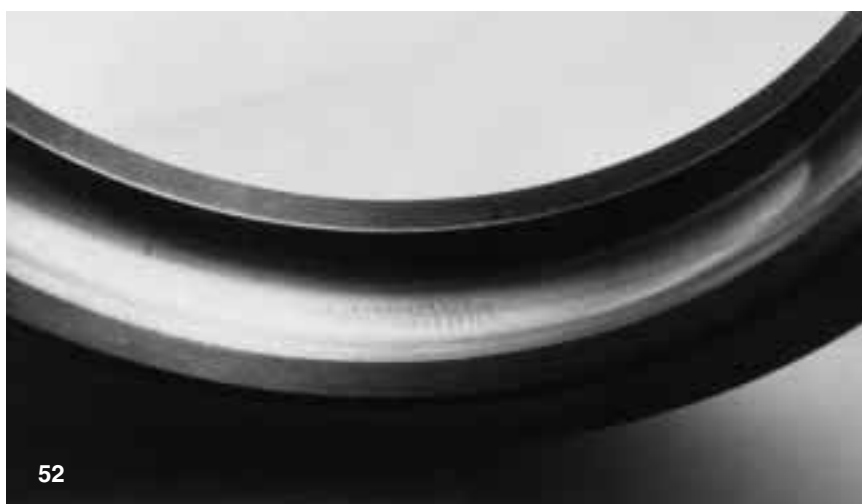
Fig 52 Deep groove ball bearing with electric current damage in zigzag pattern. It is assumed that burns of this configuration arise when the momentary passage of high amperage current is accompanied by axial vibration

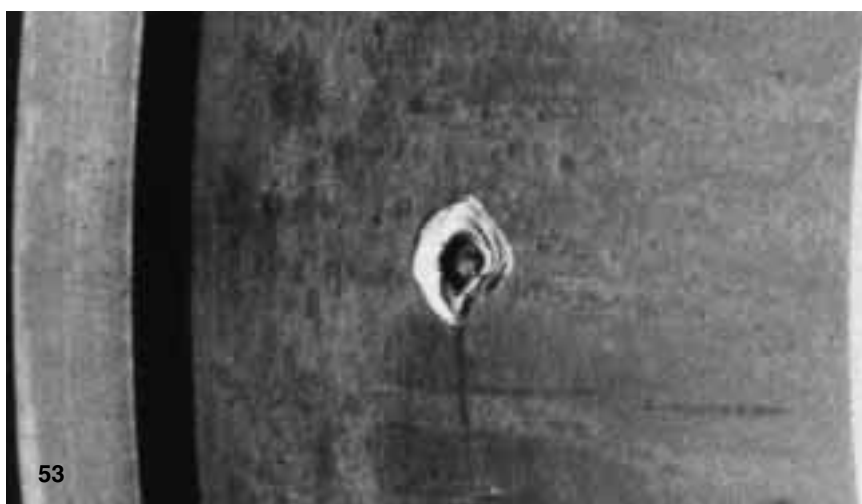
Fig 53 A railway axlebox bearing damaged by the passage of high amperage current while the bearing was not running

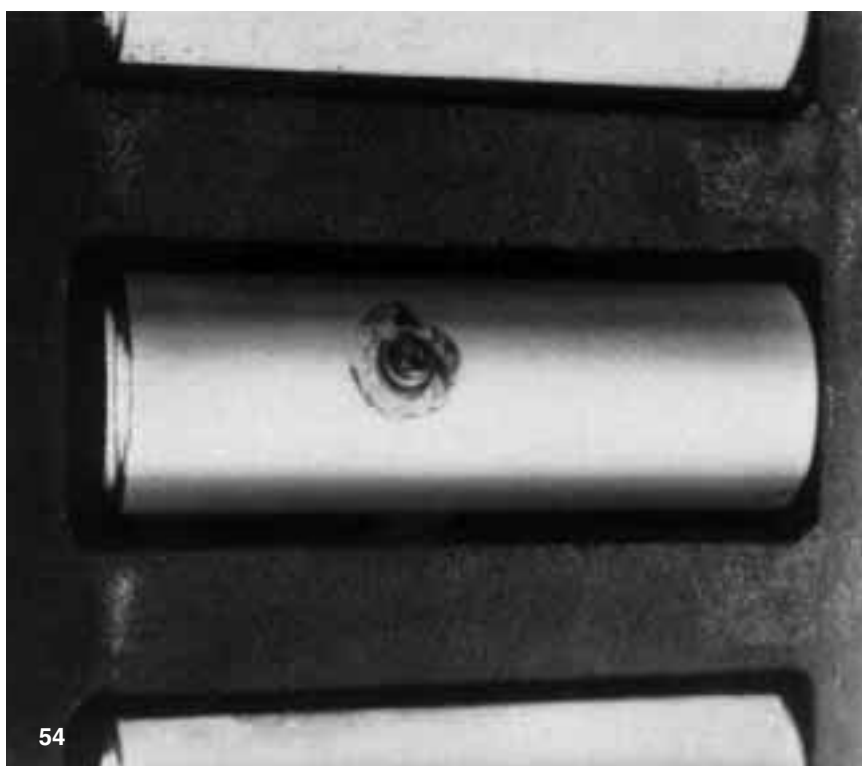
Fig 54 Roller of a railway axlebox bearing damaged by electric current (same bearing as in fig 53)

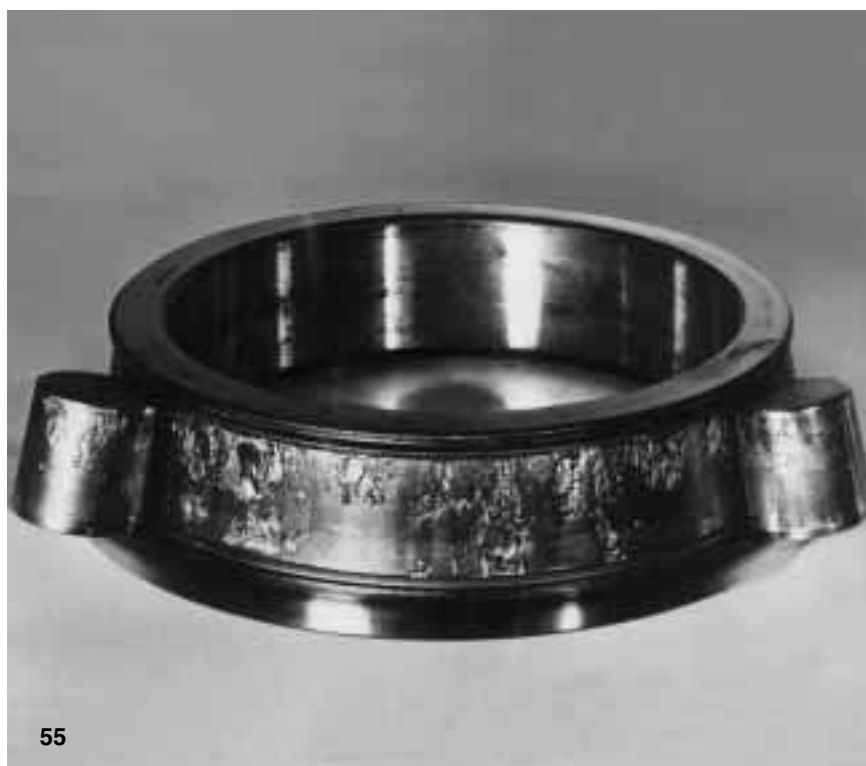
Fig 55 Flaked cone and rollers of taper roller bearing. Heavy loading and inadequate lubrication are the causes of this damage

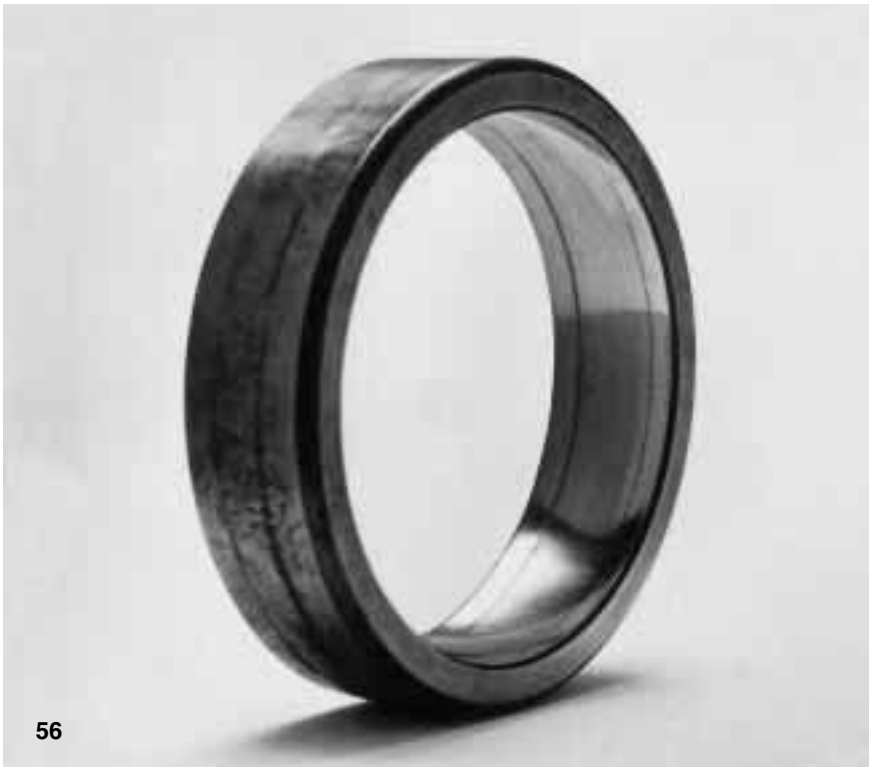
Fig 56 Outer ring of a self-aligning ball bearing that has been driven too far up its tapered seating. The bearing had only performed a few revolutions when the damage was detected. Flaking would soon have occurred if the bearing had been put into service

Appearance	Cause	Action
Heavily marked path pattern in raceways of both rings.	Preloading on account of fits being too tight.	Alter the fits or select bearing with larger internal clearance.
Flaking usually in the most heavily loaded zone.	Excessive drive-up on a tapered seating.	Do not drive the bearing so far up its tapered seating. Follow carefully the instructions given by SKF.
	Single row angular contact ball bearings or taper roller bearings adjusted to give excessive preload.	Re-adjust the bearings to obtain lighter preload.
	Temperature differential between inner and outer rings too great.	Select bearing with larger internal clearance.

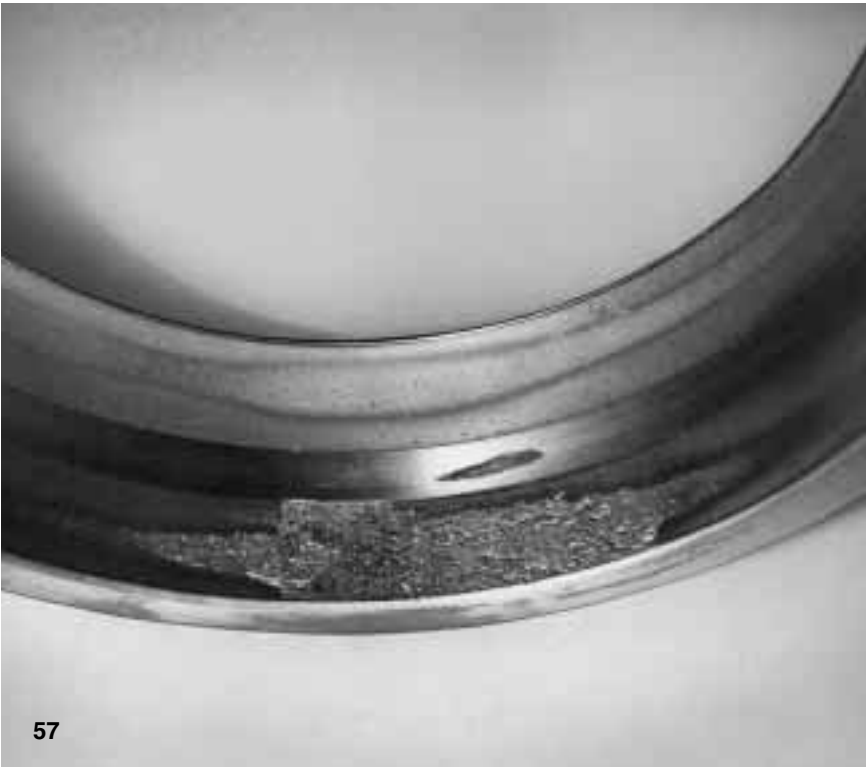
Fig 57 Flaking in the outer ring outer ring of spherical roller bearing that has been mounted in a housing with oval bore

Appearance Heavily marked path pattern at two diametrically opposed sections of either bearing ring. Flaking in these sections.	Cause Oval shaft or oval housing seating. The latter is a common defect in split housings and machine frames. The bore of plummer blocks mounted on an uneven base becomes oval when the base bolts are tightened.	Action Usually it is necessary to manufacture a new shaft or a new housing to remedy this defect. One expedient is to spray metal on the components and then regrind. If it is a matter of an oval shaft with the bearing mounted on a sleeve, it is possible to adjust the shaft by grinding, in certain cases. Adjust the base.
--	---	--

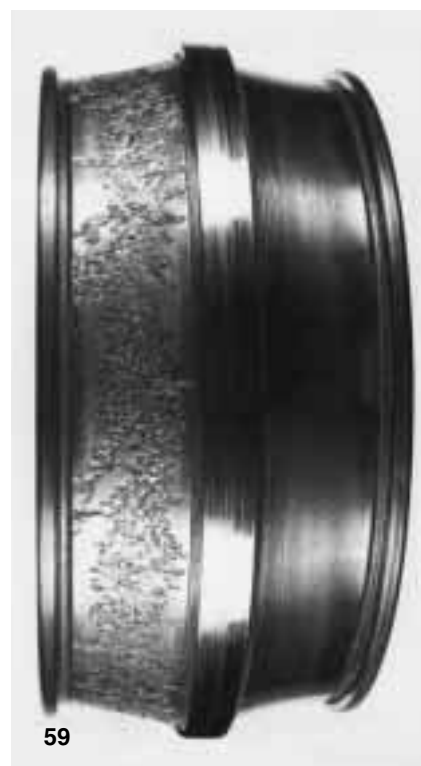
Fig 59 Flaked inner ring of a spherical roller bearing. The extent of the flaking around one entire raceway indicates that the axial load has been very heavy in relation to the radial load

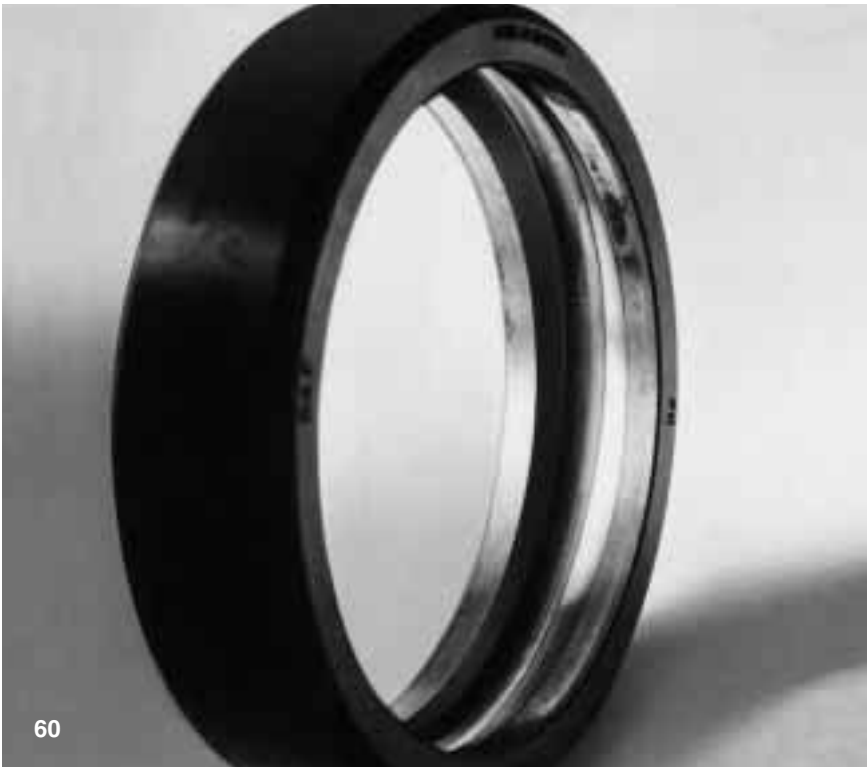
Fig 60 Deep groove ball bearing outer ring that has been out of alignment with the shaft. The ball path has an oval configuration on account of the misalignment. The result is the same as with oval compression, see page 31

Appearance	Cause	Action
Deep groove ball bearings: diagonal path pattern, severely marked at two diametrically opposed sections. Cylindrical roller bearings: flaking at the edge of the raceway.	Bearing seatings out of alignment. Bearing mounted on the skew.	Rectify the seatings. Use mounting sleeve with parallel faces.

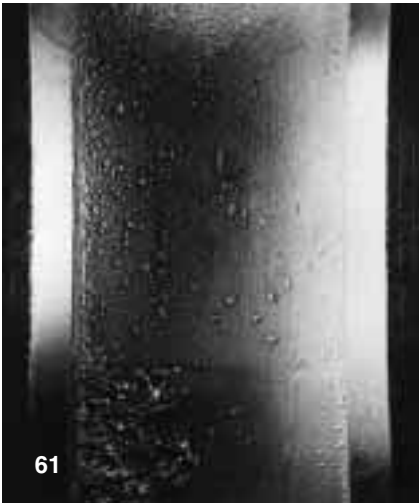
Fig 61 Cylindrical roller bearing inner ring with flaking at one side of the raceway, as a result of overloading due to misalignment

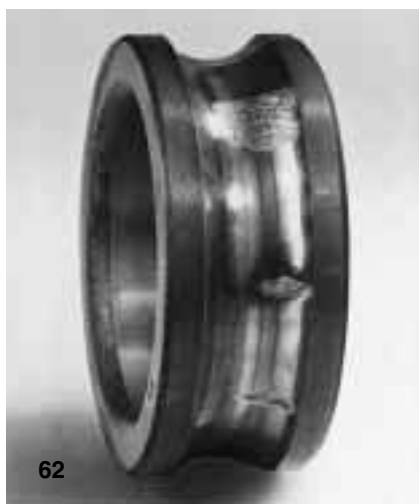
Fig 62 Various stages of flaking in the inner ring of a deep groove ball bearing. The ring has been mounted with interference fit on the shaft and blows have been directed against the outer ring, causing the mounting force to pass through the balls, which have produced the indentations

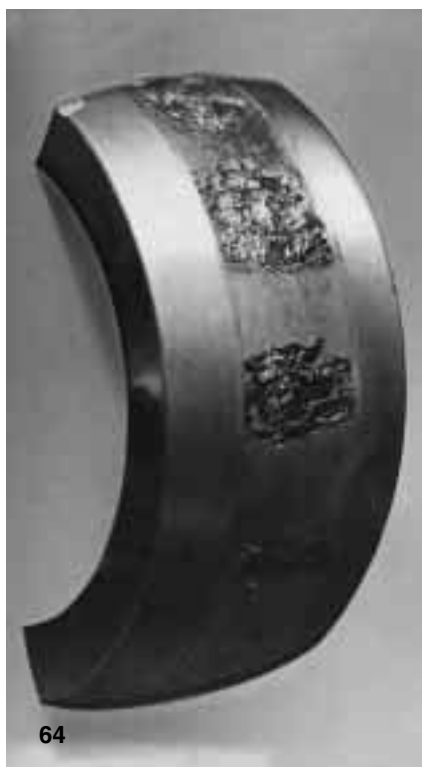
Fig 64 Inner ring of a cylindrical roller bearing with extensive flaking caused by smearing of the kind depicted in fig 65

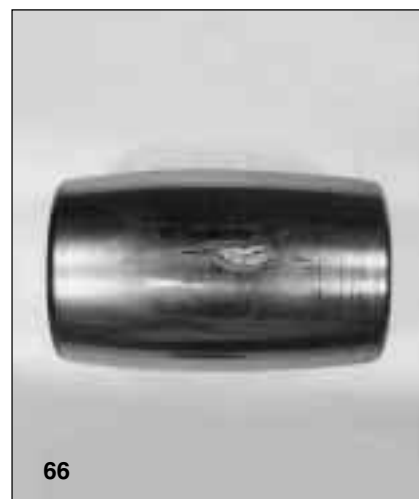
Fig 66 Flaking originating from deep seated rust on the roller of a spherical roller bearing

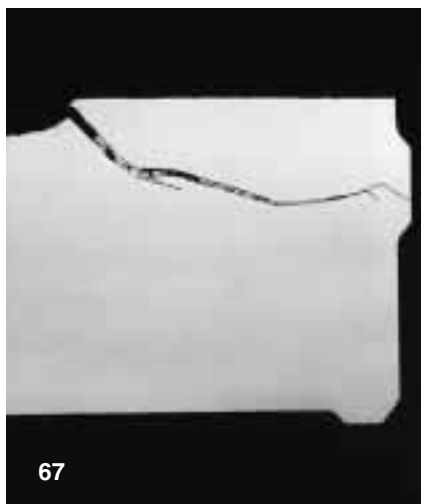
Fig 67 Cross section through the roller depicted in fig 66, showing the way in which the fatigue crack extends beneath the surface. The fully developed flaking originated in the same manner

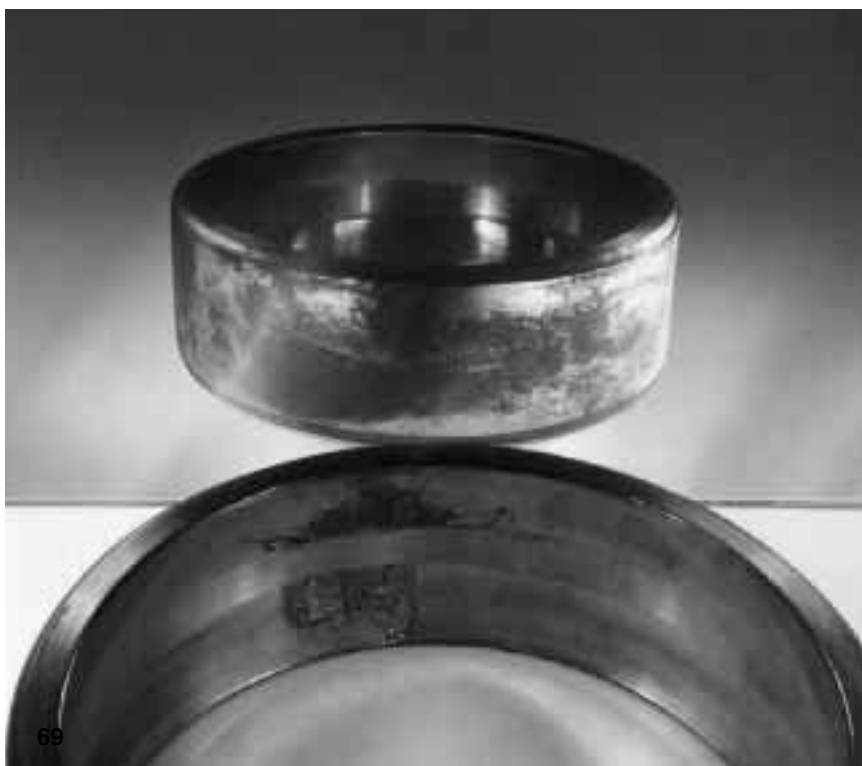
Fig 69 Flaking in the raceways of the outer ring of a spherical roller bearing. Corresponding area of advanced fretting corrosion on the outside surface (for this photograph the ring has been placed in front of a mirror). Development of the corrosion has been accompanied by an increase in volume that has led to deformation of the bearing ring and localised overloading. The results have been premature fatigue and flaking

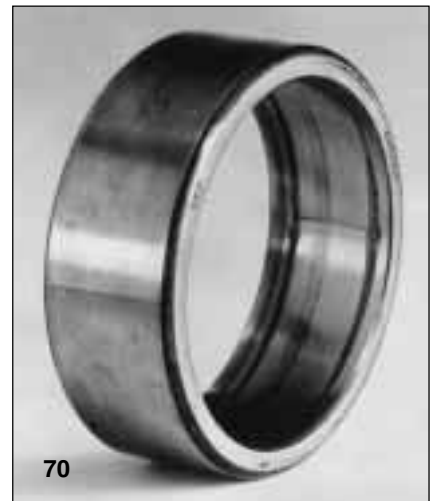
Fig 70 The outer ring of a self-aligning ball bearing with flaking caused by craters that have formed in conjunction with the passage of electric current. It is evident that the flaking has originated at the craters, from where it has spread out in both directions. Detached fragments of flaked material have in turn caused indentations and further flaking

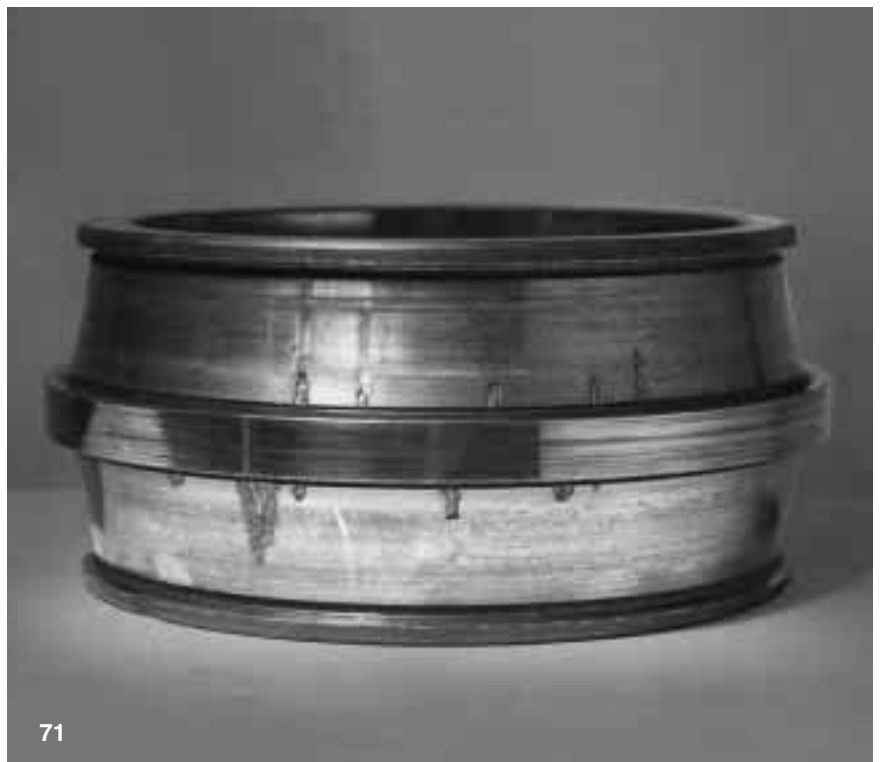
Fig 71 Flaking in both raceways of the inner ring of a spherical roller bearing. The flaking has originated from the vibration markings

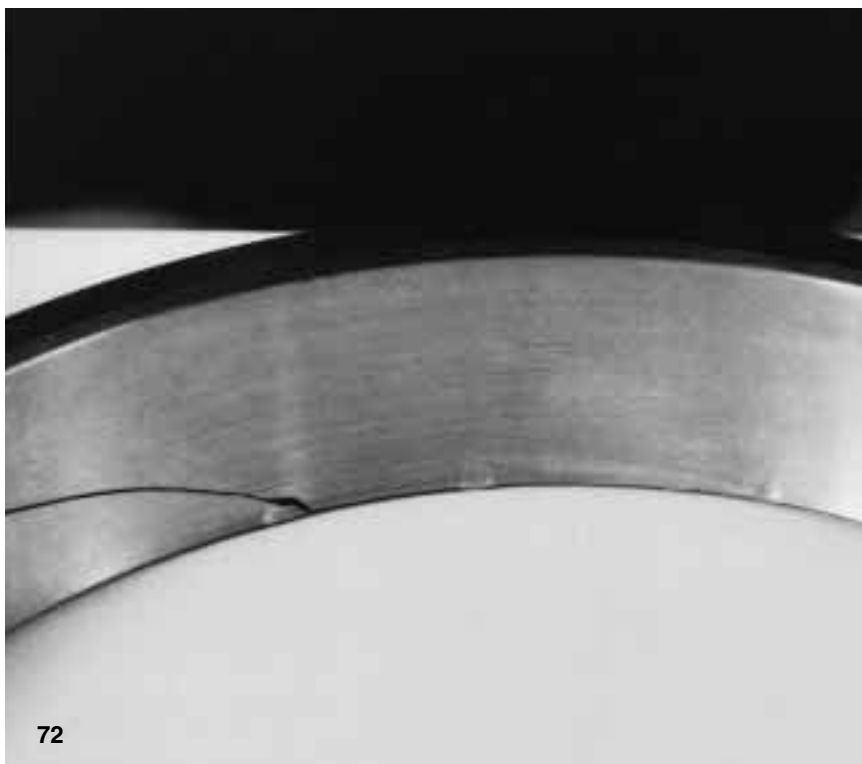
Fig 72 Fractured outer ring of a self-aligning ball bearing. The indentations visible at the bottom edge of the ring were caused by rough treatment and the crack originated at one of these indentations
