Bearing failures and their causes

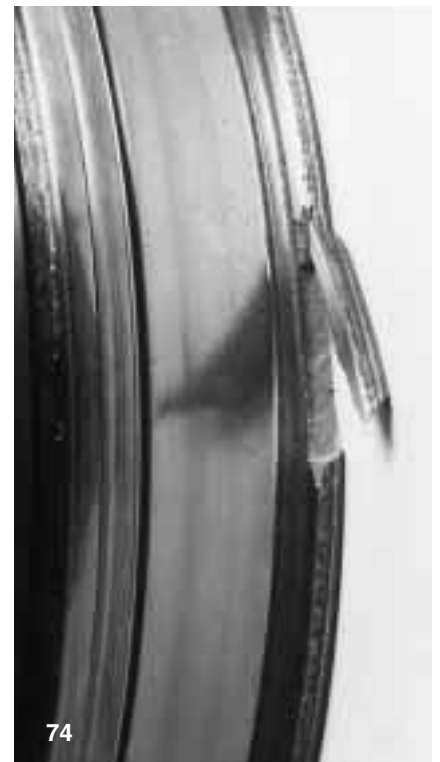
Fig 74 Inner ring of a spherical roller bearing with outer flange fracture produced by direct hammering

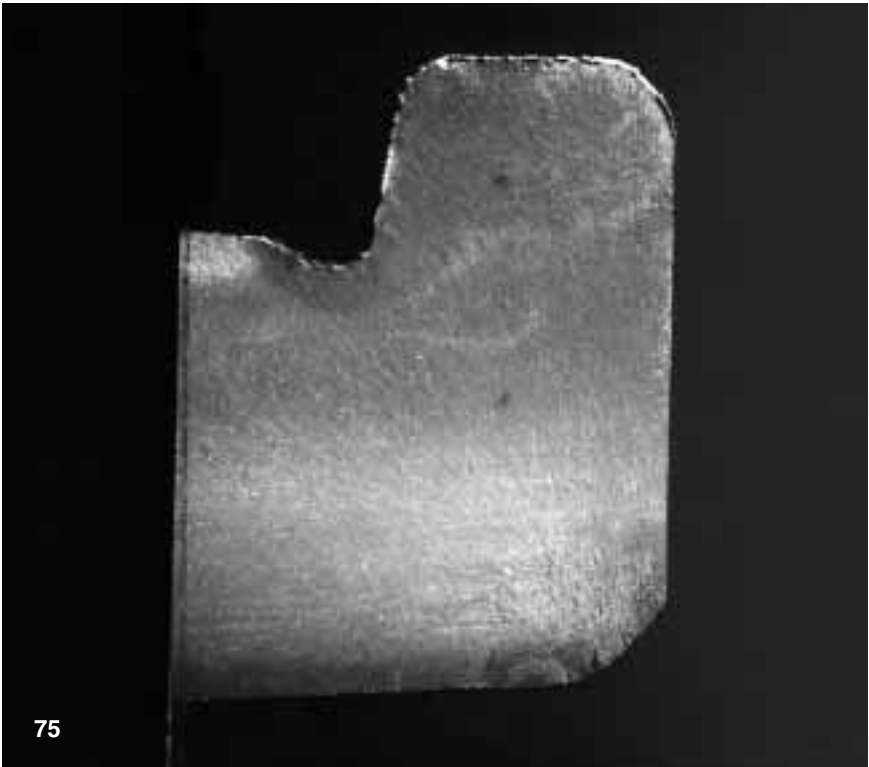
Fig 75 Section of the inner ring of a spherical roller bearing – 3,5 × magnification. The ring has cracked because of excessive drive-up. The fracture originated at the dark area by the bore chamfer

Appearance The bearing ring has cracked right through and has lost its grip on the shaft.	Cause Excessive drive-up on a tapered seating or sleeve. Interference fit on cylindrical seating too heavy.	Action Follow carefully the SKF mounting instruction concerning bearings on tapered seatings. Alter the fit.
---	--	---

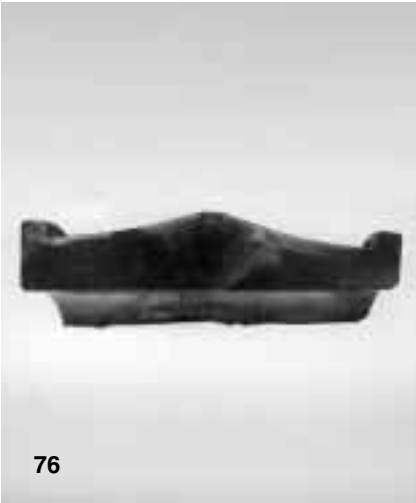
Fig 76 Fractured surface of the inner ring in fig 75

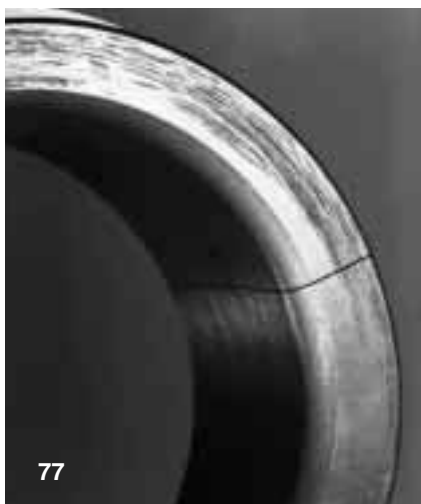
Fig 77 Spherical roller bearing inner ring that has cracked right across following smearing of one face. The ring has been mounted to about a spacer that has not had a sufficiently tight fit on the shaft. Consequently the spacer has rotated relative to the shaft and the bearing ring

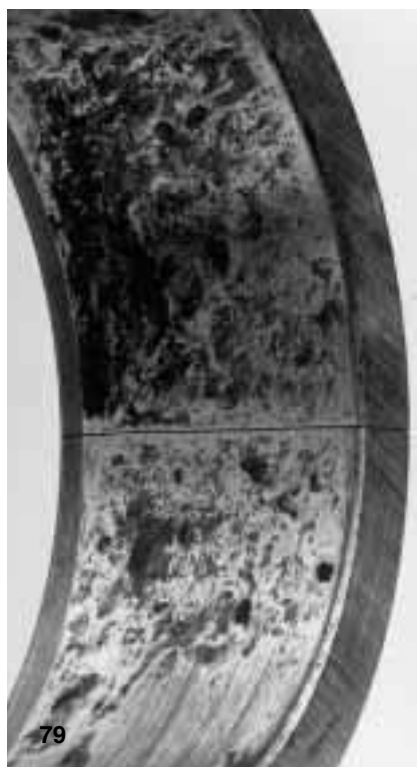
Fig 79 Spherical roller bearing inner ring with fretting corrosion and a transverse crack right through the ring. The fretting corrosion has caused the cracking
