TLGU 10

# SKF Ultrasound Lubrication Checker

Ultrasonic sensor improves maintenance practices when re-lubricating bearings

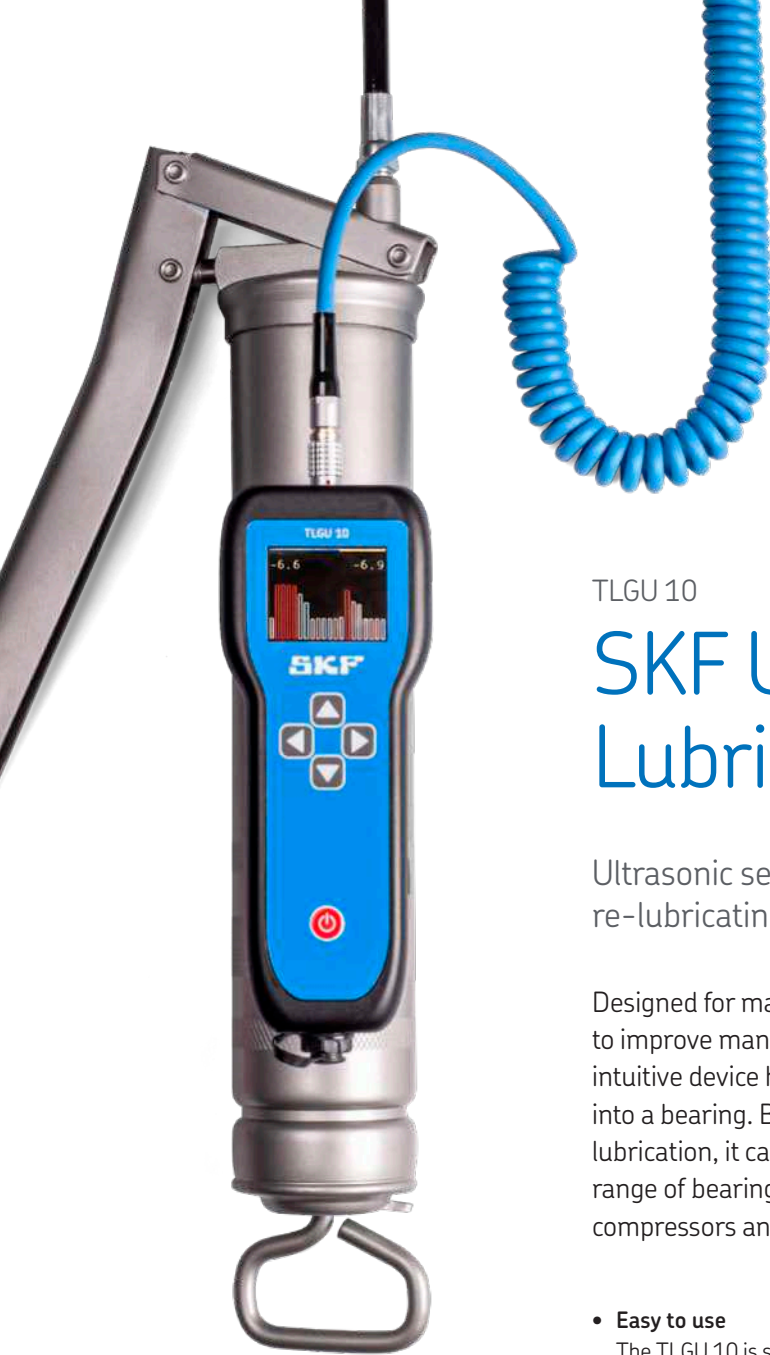
Designed for maintenance technicians, the TLGU 10 uses ultrasonic technology to improve manual re-lubrication. When connected to a grease gun, the intuitive device helps a technician to dispense the correct amount of lubricant into a bearing. By overcoming the problems associated with over- or under-lubrication, it can help to extend bearing life. The device is recommended for a range of bearing applications including electric motors, pumps, fans, compressors and conveyors.

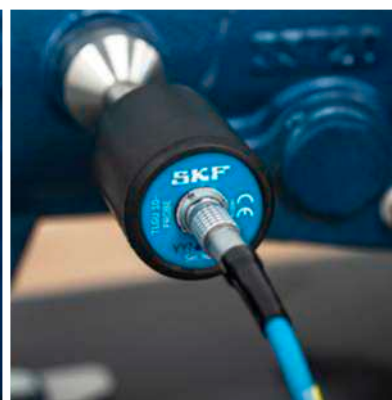
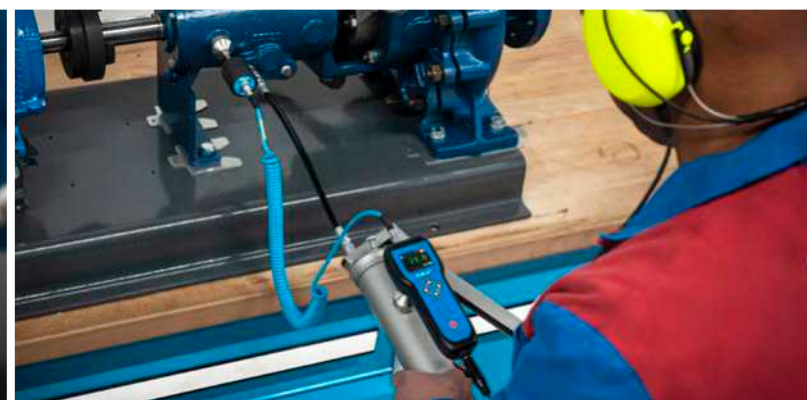
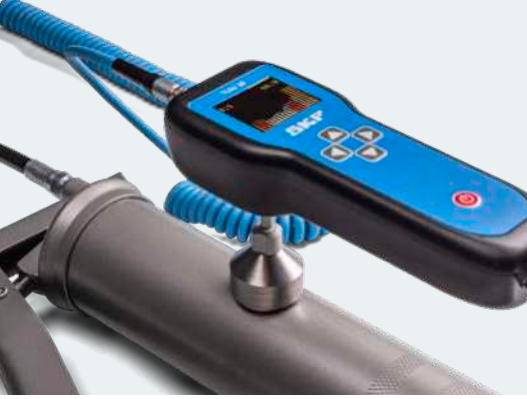
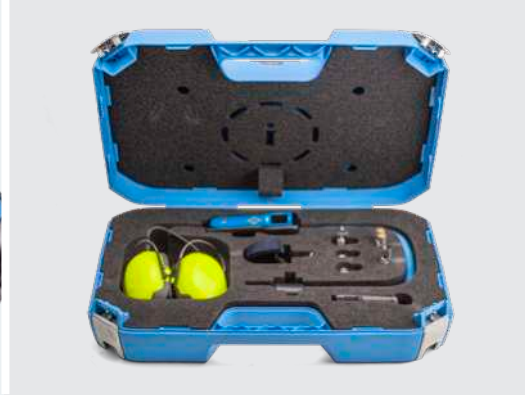
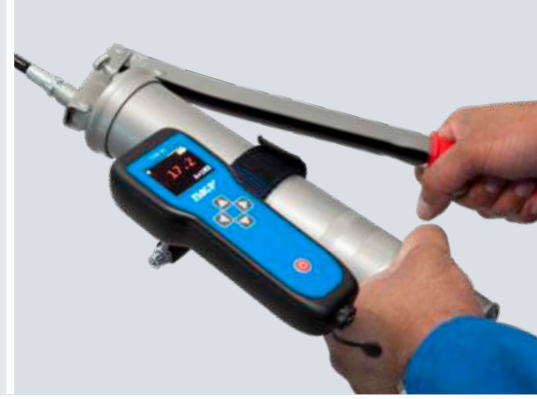
The device is simple to use, and relies on a robust, repeatable ultrasound sensor that is optimised for harsh conditions. The sensor monitors the sound of lubricant filling the bearing. Once connected to a grease gun, the

TLGU 10 allows a technician to listen to this sound, via headphones. The sound changes abruptly at the point where the correct amount of lubrication has been applied. In addition, a coloured display indicates noise levels for ease of use.
